E - S a i l F P 7

Tether Reeling Test Report

ES-RT-REP-DLR-31001

This report presents the results of the tether unreeling tests performed at DLR in February 2011. The tests are performed to analyze the tether behaviour during the unreeling procedure and co investigates the performance of a chosen deployment concept.

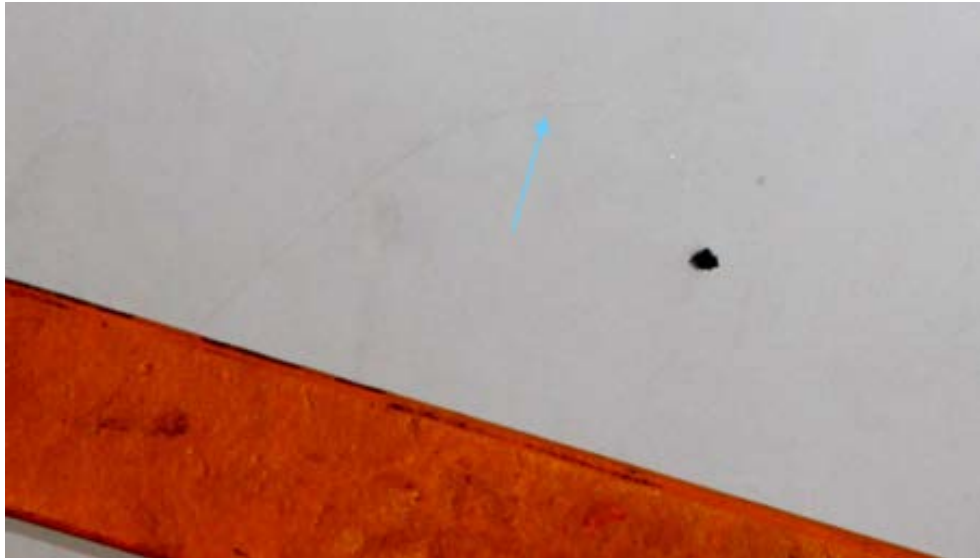
Figure 8: Tether end mass hit the ground in test run two and creat a small loop.

In this test the complete height of the lifting platform was used. That denotes that the end mass hit the ground. The unreeling of the whole length took 25:26 minutes. Due to the difference of the platform height and the tether length, it was not possible to stop the unreeling process at the same moment when the end mass hit the ground. Even with the increased visual contrast of the end mass, the test operator was not able to detect the moment of contact. Thus, the tether made a small loop on the ground, shown in Figure 8. This had no effect on the test results.

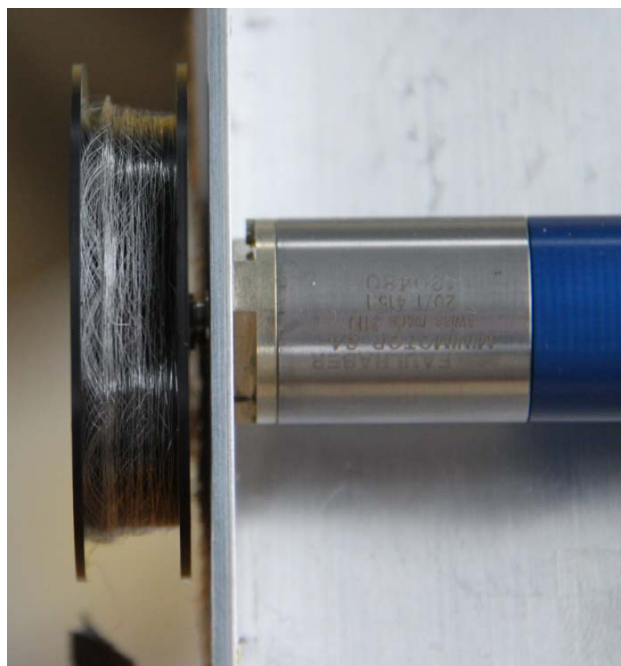
Figure 9: The upreeled tether after the second test run.

The unreeling process was done without problems, only a small bow formed again due to the thermal lift. During the upreeling, then thermal lift influenced the tether I that way that it was pulled on one side of the reel. Thus, the tether became reeled mainly on one position of the reel. Due to the uneven surface of the reel and its soft material, the tether and the loops became catches up by the reel sidewalls and lifted over.

So the tether fall back downwards and a tug appeared on it. This tug occurred 20 times. The condition of the upreeled tether is shown in Figure 9.

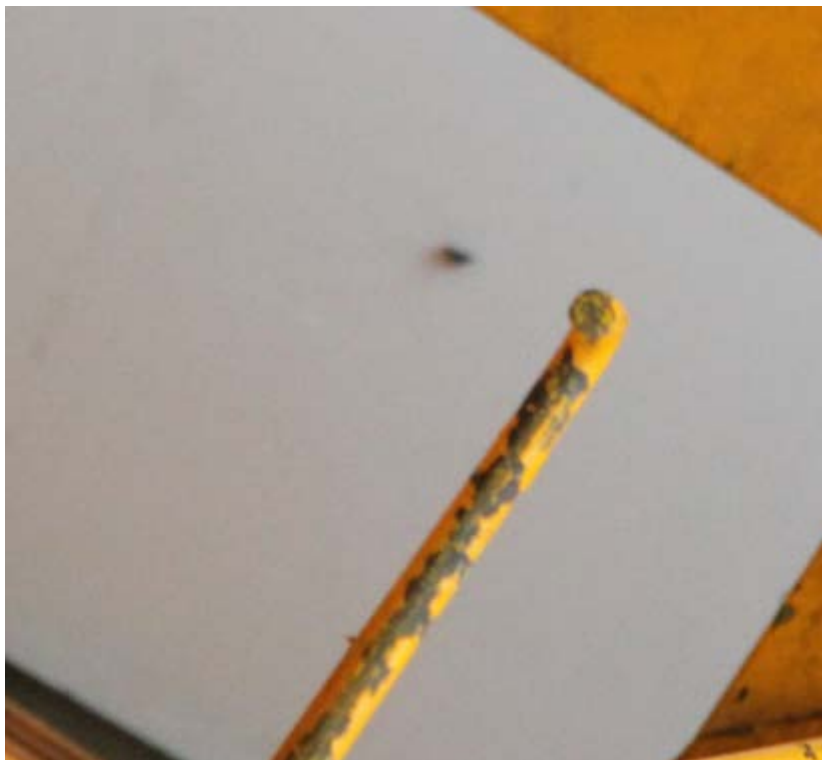
Figure 10: Tether end mass hit the ground in the third test run.

The unreeling of the tether succeeds without a problem. That shows that many stacked layers do not influence the unreeling behaviour. As the test before, the tether hit the ground, shown in Figure 10. The time for unreel the whole tether was 25:21 minutes. In this test run the tether has also a small bow caused by the thermal lift noticed in the indoor test facility.
